# Sinking the Myths

A Review of the Evidence  
The May 22, 1968 Loss of the USS Scorpion  
By Stephen Johnson

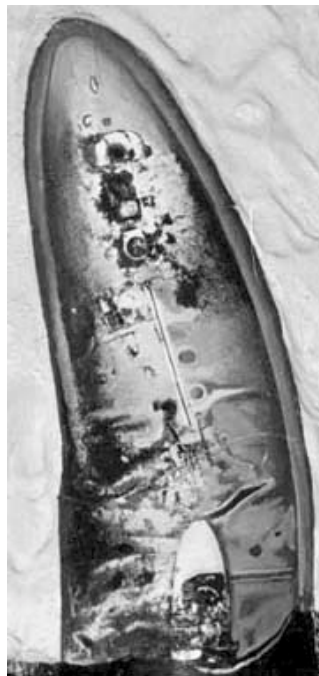
Above is a model of the torpedo compartment which includes the fairing (non-pressure hull covering) enclosing the torpedo tubes. The breech ends enter the pressure hull through a reinforced bulkhead at the forward end of the torpedo room with their muzzles extending to the bow through what is termed a free-flood area. Note the sea pressure's effects on the bow that was bent like a banana as its structure fell victim to implosion forces, once again proving Scorpion was still filled with air at the time it reached crush depth.

Some claim it was deformed upon collision with the seafloor, but the soft globigerina ooze would have cushioned the impact and it's doubtful this remarkably strong structure would have been deformed by impact in this fashion. For example: the bow of the submarine, which is a relatively weak segment of hollow fairing, appears unscathed, while the immensely strong pressure hull aft of the bow is bent and crumpled.

Note the wrinkling of the two-inch steel which covers massively strong reinforcement rings positioned every 20 inches inside the hull. The forces required to do this type of damage are almost inestimable. There is no torpedo blast damage visible inside or outside this section of hull which is sheared from the obliterated operations compartment at the bottom of this image.

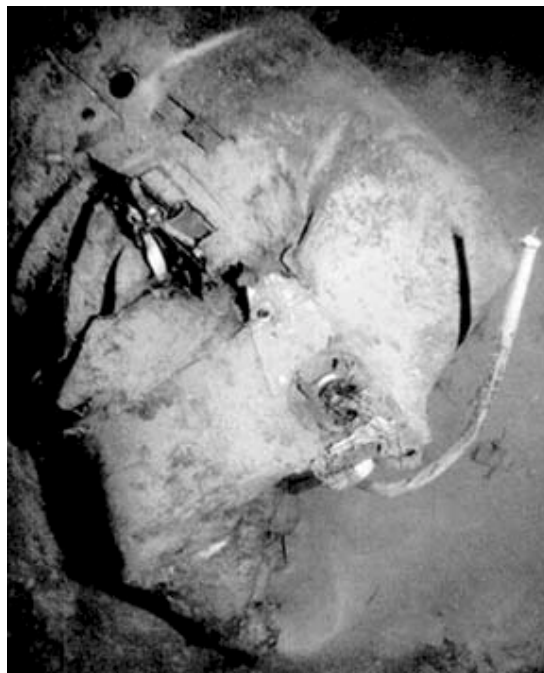
This photograph of the aft end of the torpedo room was taken by a towed camera sled deployed from the USNS Mizar in October 1968. It shows the bending of the Scorpion's hull steel inward and downward by implosion forces. The operations compartment directly behind the torpedo room has been obliterated. None of this damage bears the earmarks of a torpedo blast. The piping is the remnants of one of the submarine's periscopes. The forward edge of the fairwater sail, or conning tower, ended where the pointed outline ends forward of the collapse damage.

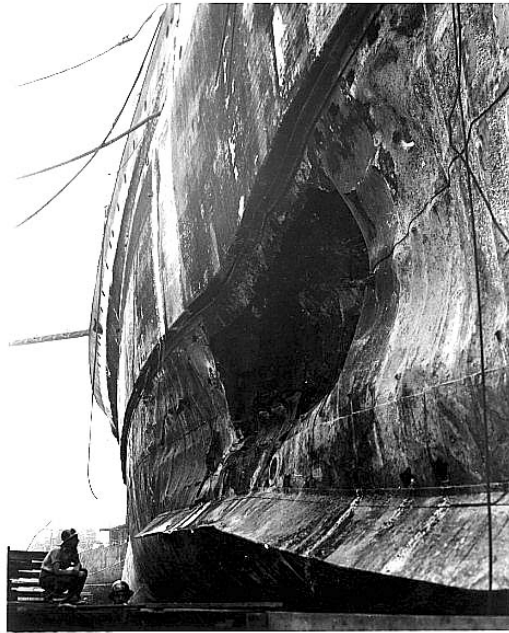
Above is an example of torpedo damage on the "soft" portion of the USS West Virginia during World War II. The torpedo struck just below the "armored belt" or the "torpedo belt" of the warship which is the thicker band of steel just above the torpedo blast hole. Torpedoes create unmistakable damage on the hull of a ship or a submarine. No damage even approximating this torpedo hole is visible anywhere on the Scorpion's wreckage. The HY-80 hull steel of Scorpion, a version of the famed Krupp Armor, was originally developed as protection for aircraft carrier hulls during and after World War II. Its high-strength and high-ductility characteristics made it ideal as hull steel in a new class of deep-diving submarines including the Scorpion.
